Discrepancies on the Spilled Volume in the Aznalcóllar Mine Disaster

Marcos Sanz-Ramos^(1a), Ernest Bladé^(1b) and Josep Dolz^(1c)

Abstract

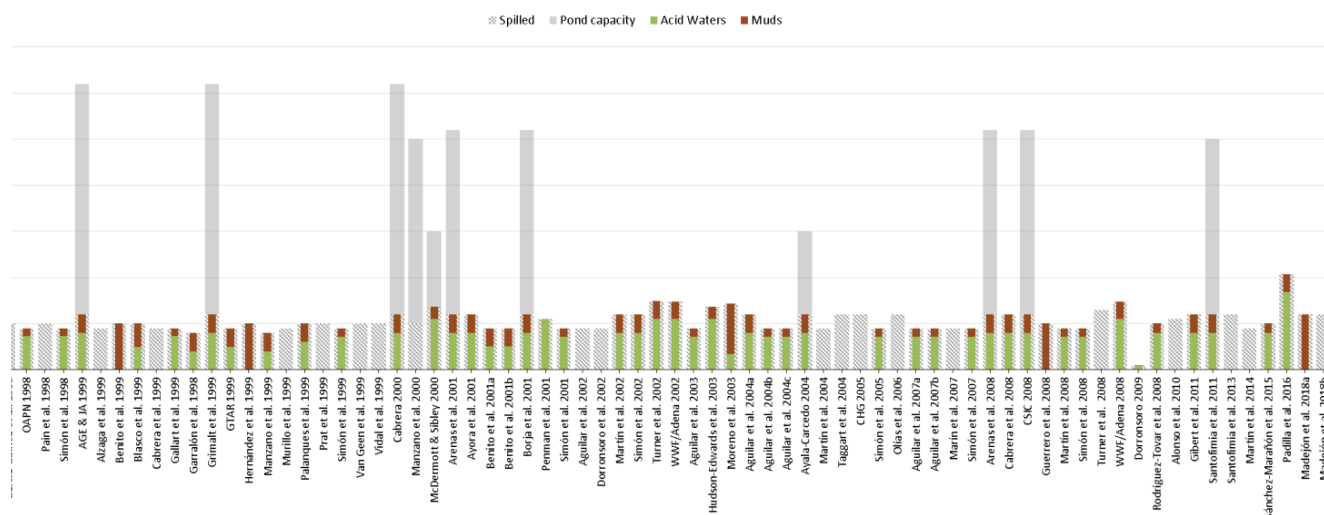
Figure 1. Recompilation of the different volumes found in the literature: pond capacity at the moment of the failure (grey bar), spilled volume during the event (grey dashed-bar), spilled volume of acid waters (green bar), and spilled volume of muds (brown bar).

The spilled volume ranges widely, from 0.45 hm³ (Dorransoro, 2009) to 10.32 hm³ (Padilla et al., 2016). It is worth noticing that Moreno-Millán and Valdés-Morillo (2003) probably confused the type of fluid as the values they present are switched with respect to the values proposed by others authors (Figure 1). Additionally, some discrepancies have been also found in the values published in different publications of the

The first estimation of 4.5 hm^3 presented by CMA (CMA, 1998) is the most referenced value. Despite that, a general consensus is observed being the value of about 5 hm^3 for the spilled volume. A year later, the value was increased up to 6 hm^3 by the re-evaluation made by AGE and JA (1999). López-Pamo et al. (1999) carried out a detailed cartography of the extension of the deposited muds, calculating their volume as 1.98 hm^3 but omitting the volume of acid waters. One of the most recent value, presented in detail by Padilla et al. (2016), is the highest one with 10.32 hm^3 , more than twice that the one initially estimated.

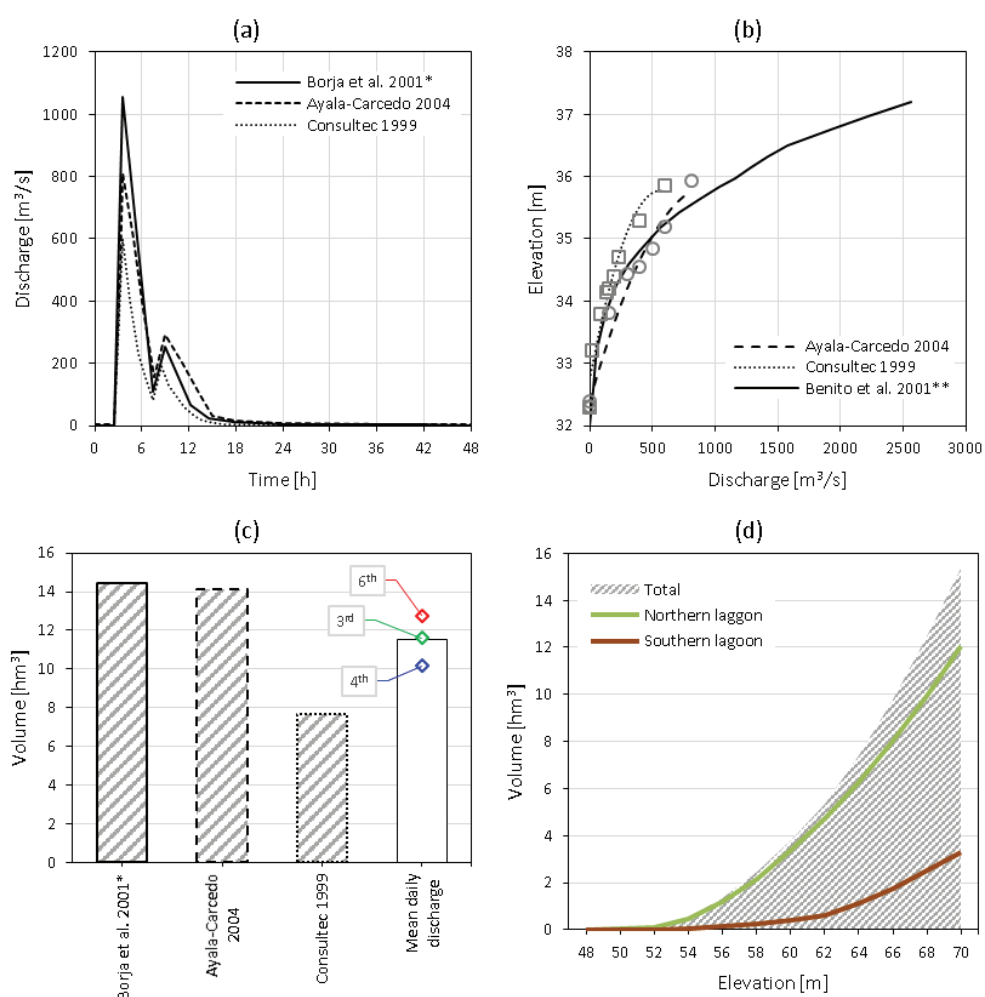
The hydrograph at EA90 (Figure 2a, dotted line) was first presented in the unpublished document of Consultec Ingenieros (1999), with a maximum discharge of $600 \text{ m}^3/\text{s}$. Later, using data from Borja et al. (2001), Ayala-Carcedo (2004) showed a similar hydrograph, but as a water-sediment hydrograph (Figure 2a, dashed line). The estimated peak discharge of $811 \text{ m}^3/\text{s}$ is 35 % more than the previous one, and it was probably overestimated due to the higher viscosity of the fluid (Ayala-Carcedo, 2004).

Figure 2. (a) Comparison of the hydrographs presented by Ayala-Carcedo (2004) (dashed line), by Consultec Ingenieros (1999) (dotted line), and calculated from data of Borja et al. (2001) (continuous line) (*) using the rating curve from Benito et al. (2001). (b) Rating curve (**) obtained by numerical modelling (source: adapted from Benito et al. (2001)). (c) Estimated volume that passed through EA90 during the event (25–26 April), the white bar obtained being the mean value of the rating curve extrapolated from polynomial adjustment of the 3rd, 4th and 6th order. (d) Elevation-volume relative curve of the pond inferred from the post-failure topography.

Three rating curves have been inferred from the previous data. Figure 2b shows the best adjustment ($R^2 > 0.95$) of the rating curve calculated here from data of Consultec Ingenieros (1999) (dotted line) and Ayala-Carcedo (2004) (dashed line), and also the rating curve inferred from data of Borja et al. (2001). These rating curves behave similarly for elevations up to 34.5 m, being less conservative the rating curve of Benito et al. (2001) (Figure 2b, continuous line). This last one, taken just downstream of the gauge station, has been used to estimate the hydrograph with data from Benito et al. (2001) (Figure 2a, continuous line). In this case, the peak discharge would be 1,056 m³/s, almost twice that estimated in Consultec Ingenieros Consultec Ingenieros (1999).

Figure 2c shows the cumulative volume that passed through EA90 during the event considering the three previously mentioned sources (Ayala-Carcedo, 2004; Borja et al., 2001; Consultec Ingenieros, 1999) and new data presented here. These values were calculated integrating the hydrograph shown in Figure 2a and averaging the mean daily discharge calculated from the extrapolation methods for the CHG data. The volume ranges from 7.6 (Consultec Ingenieros, 1999) to 14.4 hm³ (Borja et al., 2001), all of them being higher than those usually referenced in the literature (4.5 and 6 hm³). Considering the uncertainties of the inferred rating curves for the hydrographs, the most reliable spilled volume could be the average value of the mean daily discharge calculated here, of 11.5 hm³.

Figure 2d shows the elevation-volume relative curve obtained from the post-failure topography. Considering the water elevation at the pond crest, the spilled volume could potentially reach 15.4 hm³, which is slightly higher than the maximum previously estimated volume from Borja et al. (2001), of 14.4 hm³. Nevertheless, according to Alonso and Gens (2006), the water level was 4.4 m below the crest the day before the failure; with this information, the maximum spilled volume would be 9.3 hm³. So that, the spilled volume, both presented and calculated here, are within the volume that was potentially stored in the pond.

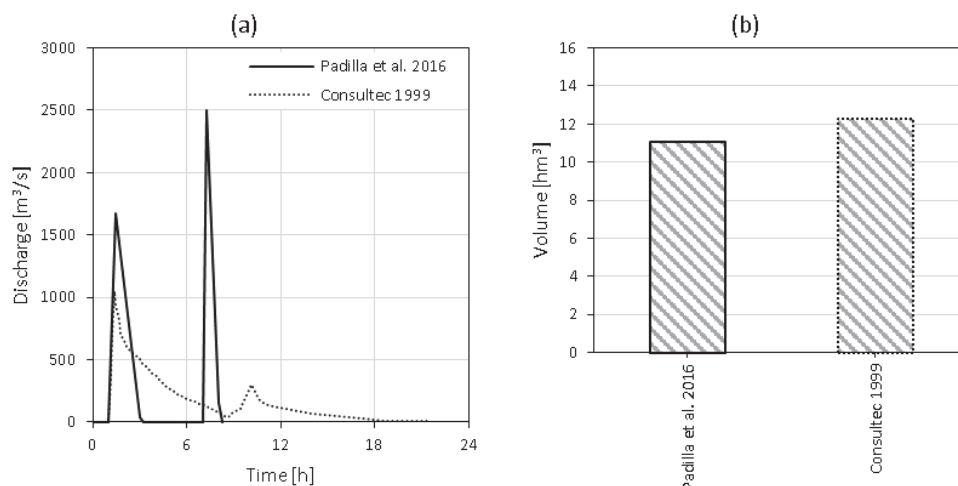
In Consultec Ingenieros (1999), the hydrograph of the spill at the pond was also estimated to be continuous by means of the inverse convolution process (Figure 3a, dotted line), with a peak discharge of 1,050 m³/s at around 1:25 AM. More recently, Padilla et al. (2016) presented a hypothetical hydrograph, also with two peaks (Figure 3a, continuous line). In contrast to the previous one, the second peak is higher than the first one, being around 1,670 m³/s (at 1:30 AM) and 2,500 m³/s (at 7:15 AM), respectively. In addition, these peaks were separated by a no-discharge period of about 3:45 hours, contrary to the observed limnograph. The volumes of these hypothetical spills are 12.3 and 11.1 hm³, respectively (Figure 3b). Both are within the potential storage capacity estimated here.

In this sense, the volume calculated from data of Consultec Ingenieros (1999) at the pond is 64 % higher than that estimated at EA90 gauge station, suggesting that the rating curve used to transform the limnograph into a hydrograph was probably inadequate. On the other hand, it is unclear whether the spill was released in two time-separately phases as is suggested by Padilla et al. (2016) because the dyke failure was very quick and probably affected both dykes concurrently (Alonso and Gens, 2006b, 2006a; Ayala-Carcedo, 2004).

Figure 3. (a) Hypothetical hydrograph of the spill at the failure point estimated by Consultec Ingenieros (1999) (dotted line) and Padilla et al. (2016) (continuous line). (b) Spill volume calculated from the previous data for the first 24 hours.

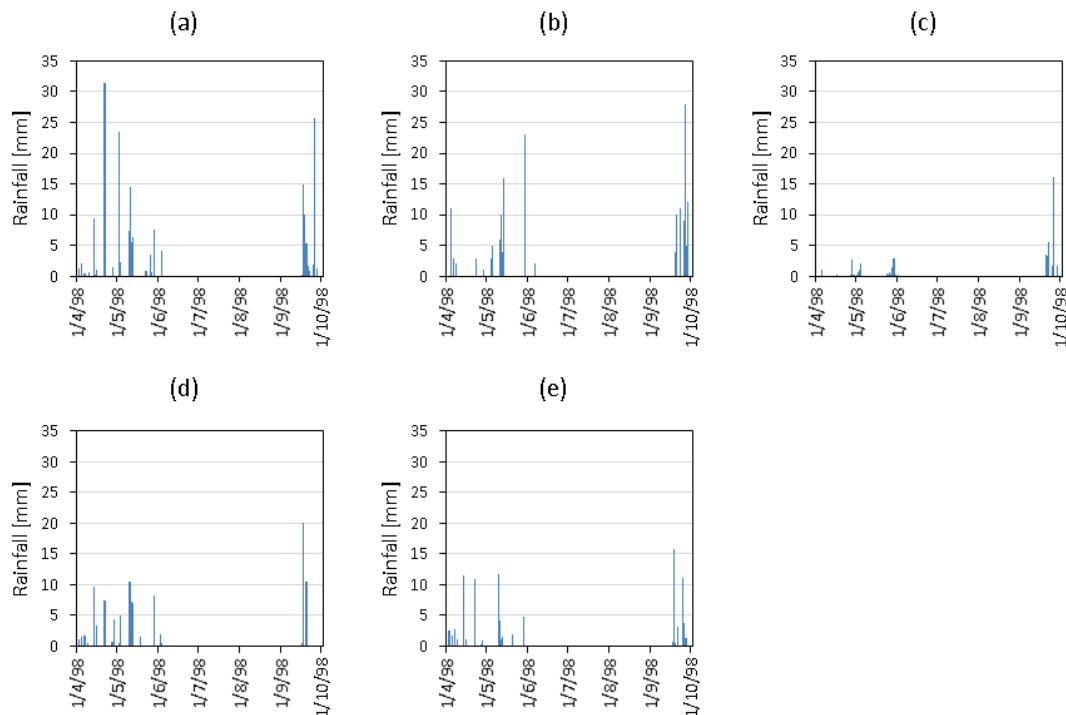
Daily cumulative rainfall data collected from the aforementioned facilities reveal three different patterns during the 1998 April–September period (Figure 4). From April to May, the weather was quite wet with more than 30 % rainy days. From May to mid-September, the rainfall was scarce or null. From mid- to end-September, rainfall events were registered again on around 50 % of rainy days.

Figure 4. (a) Daily cumulative rainfall registered at the gauge stations 5783 (a), E67 (b), 5860E (c), 5960 (d) and 5910 (e).

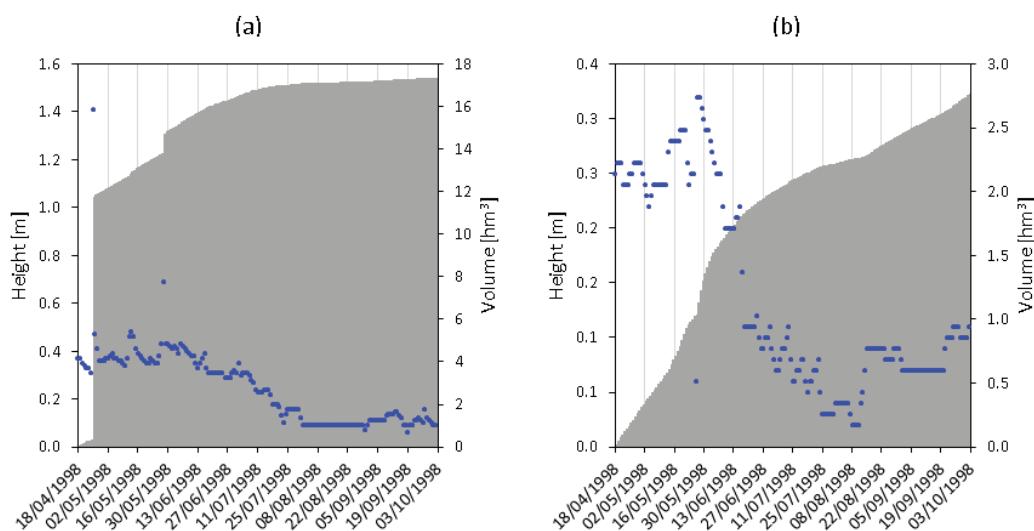
On the other hand, collected data of the water-level gauges have been grouped by days, and the mean values of the height and the registered discharge have been represented. Figure 5 shows the water level evolution for 24 weeks at each gauge station, starting a week before the failure. From the upper part of the Guadiamar River, gauge station EA56 shows a mean daily discharge of around $0.191 \text{ m}^3/\text{s}$, or $0.016 \text{ hm}^3/\text{day}$, with an important increment during the rainfall event of the last week of May (Figure 5a). During this period, the upper Guadiamar inlet mean discharge stood around 2.76 hm^3 . Additionally, a sharper increment on the cumulated volume was registered during the last week of May (Figure 5b) to a lesser extent due to inputs coming from upper Guadiamar River, and to a greater extent probably due to discharges from the Agrio Reservoir located upstream of the pond, in the Agrio River.

Figure 5. Evolution of the mean daily height (blue dots) and the cumulated volume (grey bars) at the gauge station EA56 (a) and EA90 (b).
