Exacerbation of Hydrologic Events due to Anthropogenic Causes in Arid Zones

Abstract

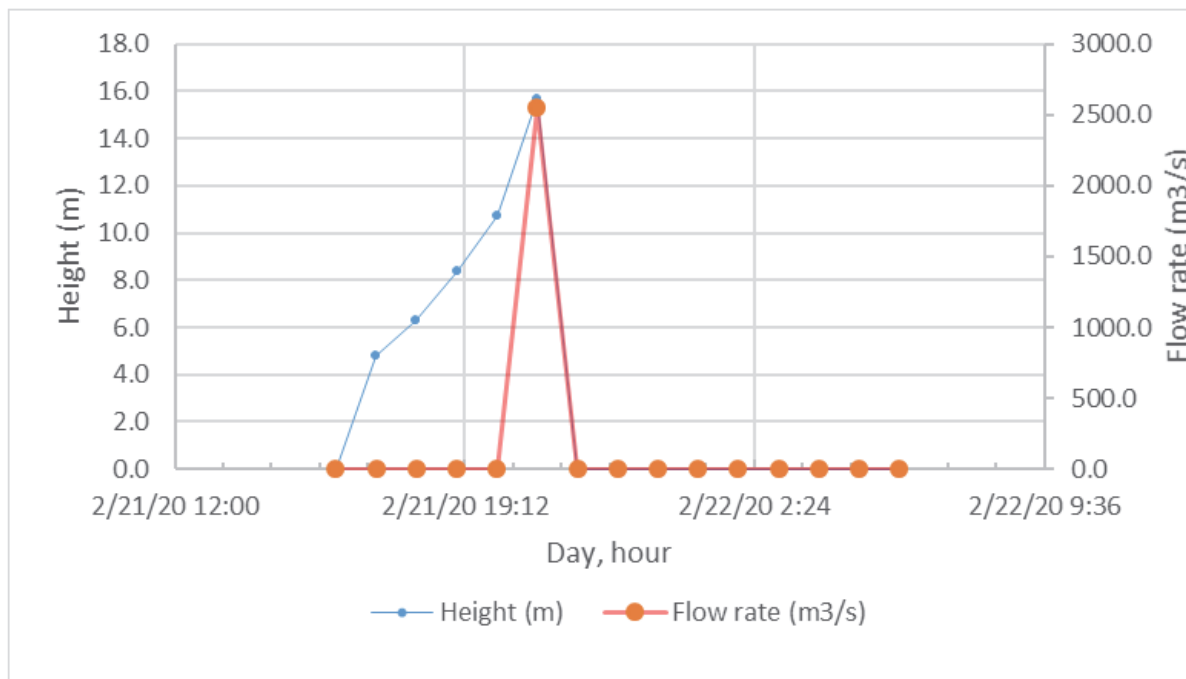
Figure 2. Hydrograph generated for the condition with embankment and dam break.

When the hydrograph shown in Table 1 is the upstream condition of the dam break simulation, the water impounded behind the embankment induces breaching of the embankment when the height reaches 15.7 m, thus generating a peak discharge of 2500.8 m³/s.

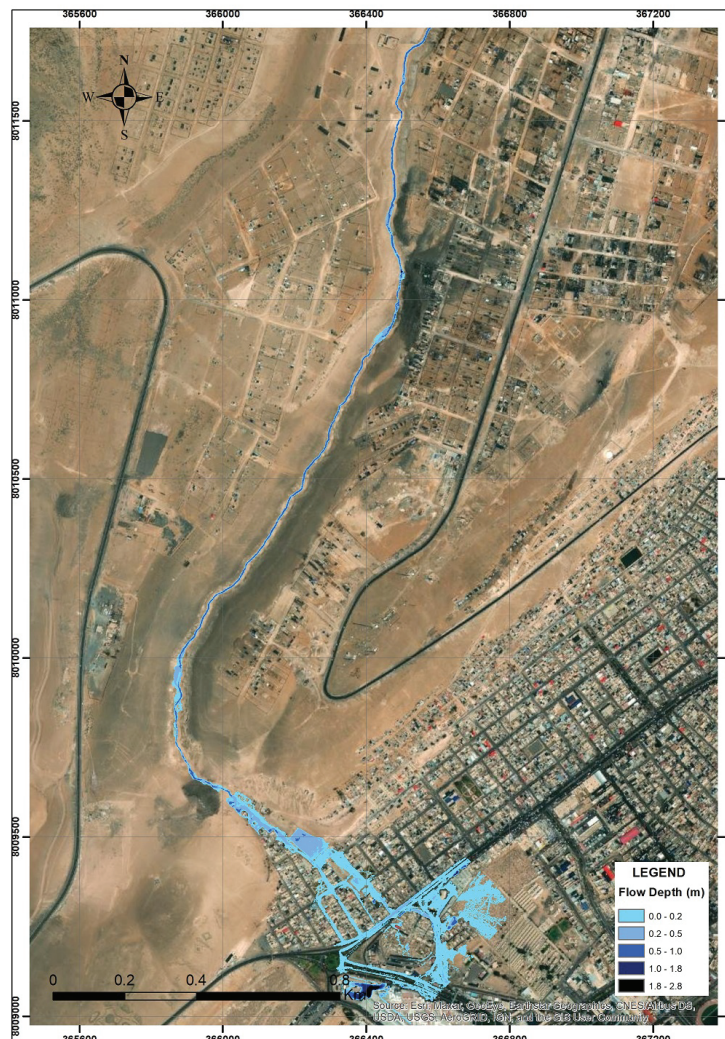
Figure 3. Output of flow depth superimposed with satellite image of the affected area for the no embankment condition.

Results of the hydraulic modeling indicate that the simulated event in the "without blockage" condition of the channel (that is, without the Camiara pass) does not generate greater flooding of the streets, as seen in Figure 3. The maximum depth within the ravine (canyon reach, upstream from the urban area) is approximately 0.20 – 0.50 m, except in a few spots where it may reach 1 m.

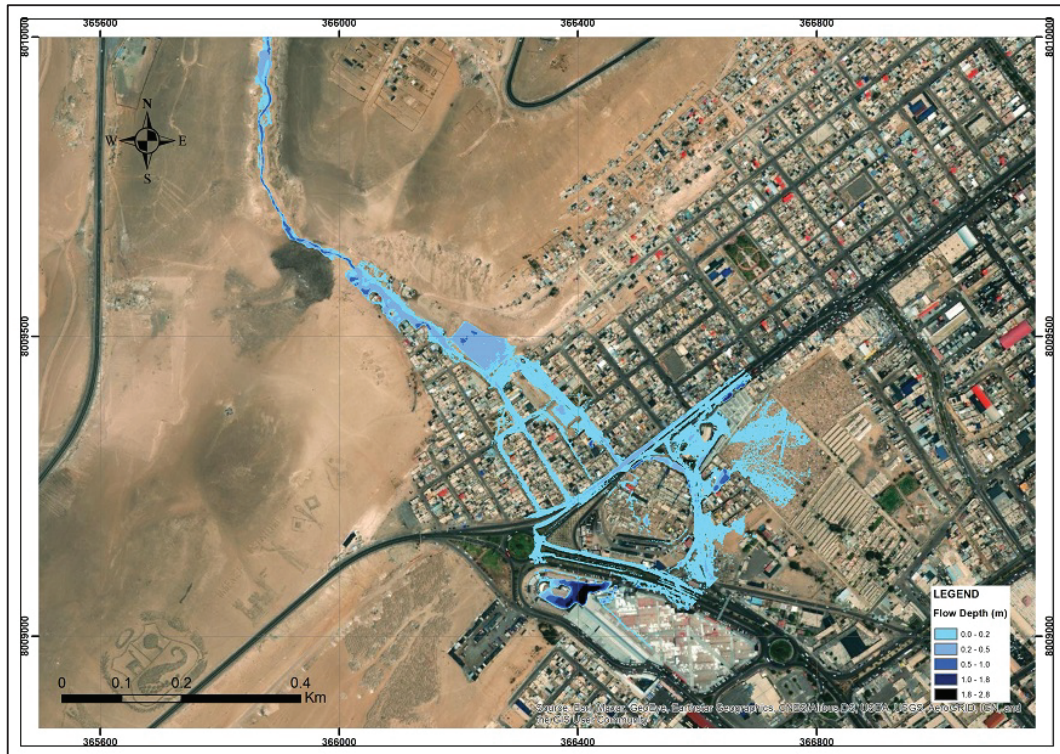
Figure 4. Flow depths for the "No embankment" scenario.

Figure 4 shows in greater detail the maximum depths of flooding. Depth of inundation in the flooded streets reaches approximately 0.2 m in most cases, because, although there is an acceleration of the flow immediately upstream of the entrance to the urban area, the flow is dispersed through the streets whose roadway is approximately 6 m and whose sidewalks are between 1 – 1.20 m wide. There is an area on the right bank of the creek near the exit where the sanitary landfill is located where there is an excavation where waste from the city of Tacna was being deposited. In this area there was a flooding of approximately 0.50 m. Immediately downstream of the roundabout there is a depressed area in which the accumulation of water would reach 1.8 m in the deepest section. Figure 5 shows flow velocities and they seldom exceed 2.5 m/s. It can be inferred from the hydrograph presented in Table 1 that inhabitants of the affected zone could have been warned of flooding at the beginning of the event as it took five hours to reach the peak flow, 10.9 m³/s.

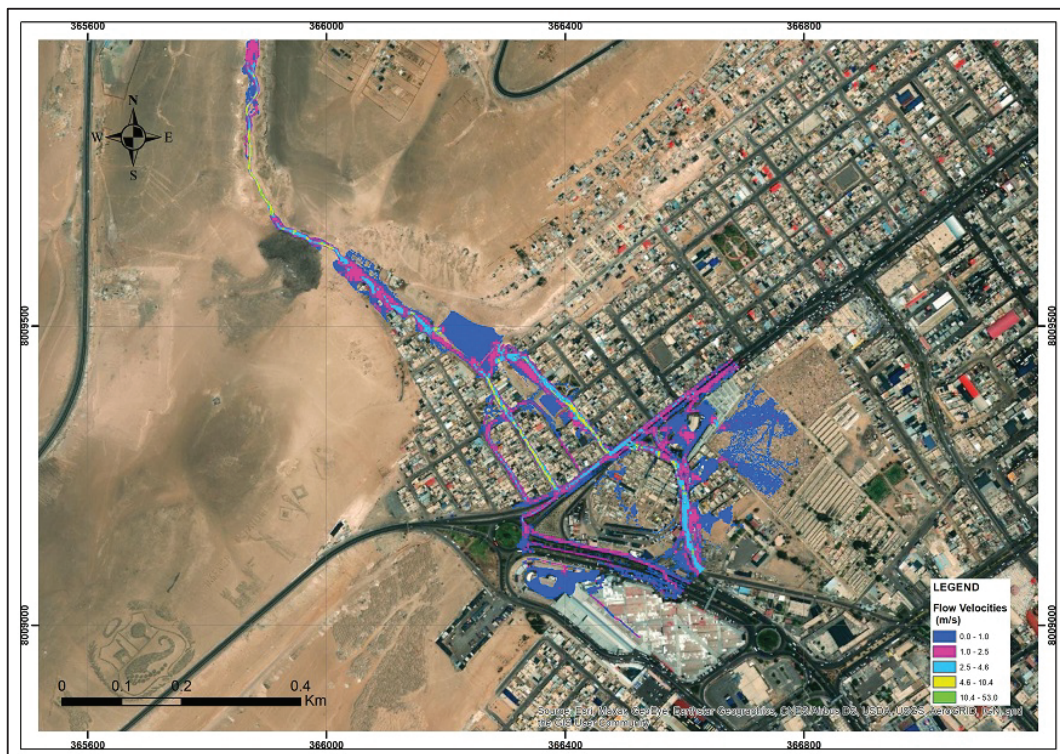
Figure 5. Flow velocities for the "No embankment" scenario.

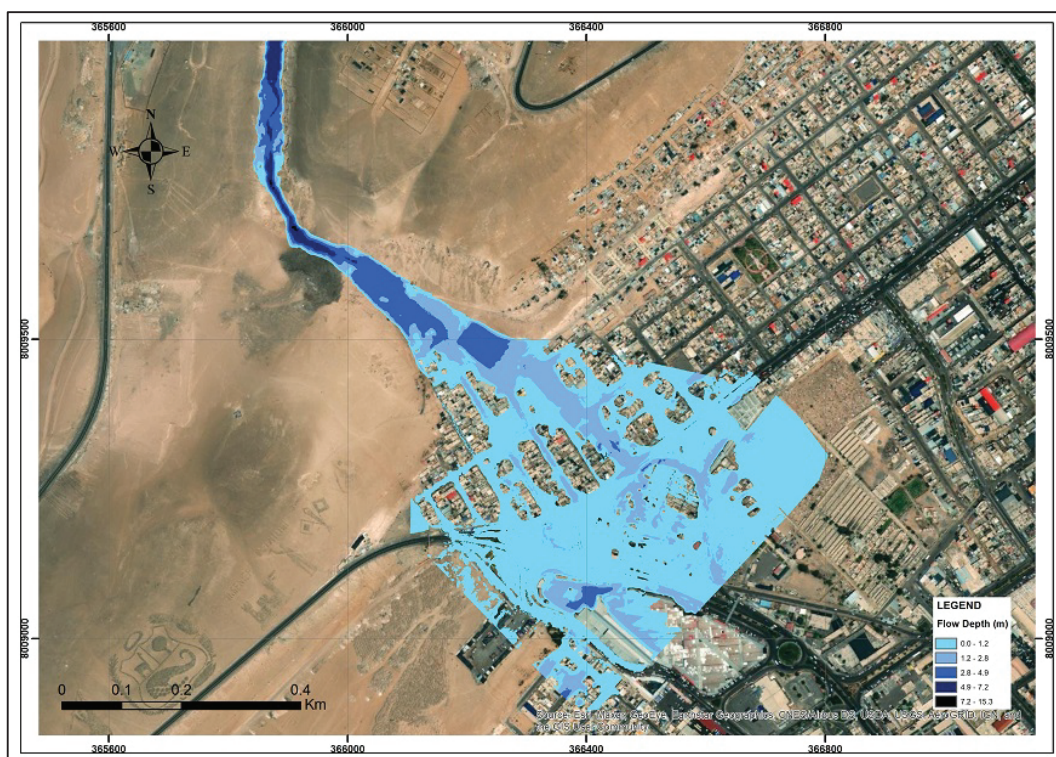
Figure 6. Maximum flow depths of the recreation of the February 21, 2020, event.

When the upstream hydrograph of the dam break is routed through Devil's Creek and into Tacna City, a large area is inundated at very high speeds. Figure 6 shows in more detail depths of flow and Figure 7 shows flow velocities. Near the creek mouth, where a human settlement interrupts the course of the creek, flow depths between 2.8 and 4.9 m are reached in the hydraulic simulation. This depth is sufficient to cover one or two floors. In addition, simulated flow velocities near the creek's mouth are from 5 to 15 m/s and may even reach 35 m/s in one of the streets (shown in yellow color). These velocities that are to be further examined, can cause destruction of houses as it happened in the buildings that were closest to the creek's mouth. Figure 8 shows destruction of a brick and concrete house where a few concrete columns remained standing. An event such the one described in section 4.1 may not have caused such destruction as the depths and velocities were not high enough.

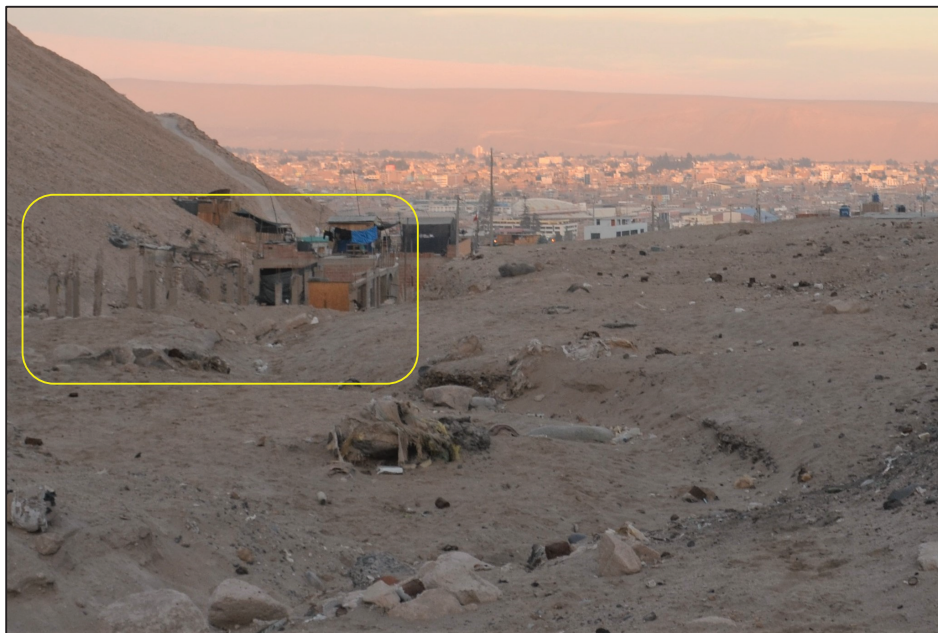
Figure 8. Houses destroyed by the February 21, 2020, flood.

The computer simulation performed using HEC-RAS 2D shows that the road embankment greatly amplified the effects of runoff in Devil's Creek. Without the embankment a maximum flow depth in the order of 0.5 m and velocities nearing 2 m/s may have occurred along the streets near Devil's Creek mouth. On one hand it became evident that no embankment that blocks the flow in Devil's Creek should be built, and, on the other hand, the human settlement located near the creek's mouth should be relocated.

Human settlements situated near Devil's Creek mouth should be relocated to a safe area.
